# Condition assessment of the wood pole RP-6-1

June 17, 2011

# Condition assessment of the wood pole RP-B-1-3

# Condition assessment of the wood pole RP-D12

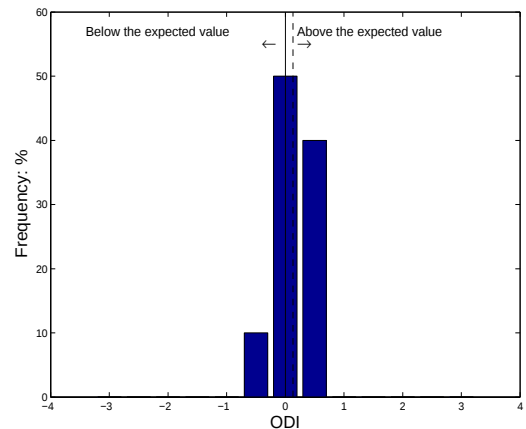
Figure 2: Overall dissimilarity index

Parameters of wave velocity, wave attenuation, and the modulus of elasticity are combined to compute an overall dissimilarity index (ODI) for each raypath. The ODI represents a number of standard deviations respect to the expected value for a new pole and, therefore, describes the overall condition assessment of a cross-section. An ODI in the range  $[-2, -3]$  means that a cross-section has 98% probability that is decayed. The mean value and standard deviation of the ODI computed from 20 raypaths are  $\mu = 0.1$  and  $\sigma = 0.3$ .

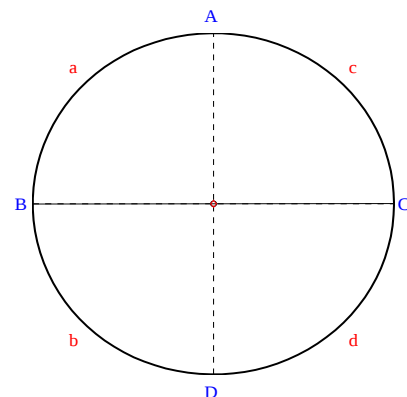
Figure 3: Decayed areas

No decayed areas were detected in the tested cross-section.

The non-destructive evaluation shows that the tested section is sound.

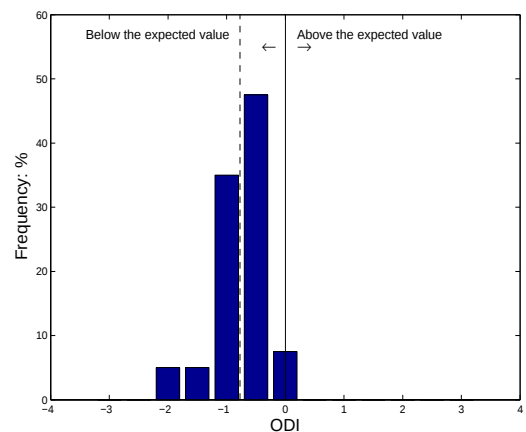
Figure 2: Overall dissimilarity index

Parameters of wave velocity, wave attenuation, and the modulus of elasticity are combined to compute an overall dissimilarity index (ODI) for each raypath. The ODI represents a number of standard deviations respect to the expected value for a new pole and, therefore, describes the overall condition assessment of a cross-section. An ODI in the range  $[-2, -3]$  means that a cross-section has 98% probability that is decayed. The mean value and standard deviation of the ODI computed from 20 raypaths are  $\mu = -0.8$  and  $\sigma = 0.5$ .

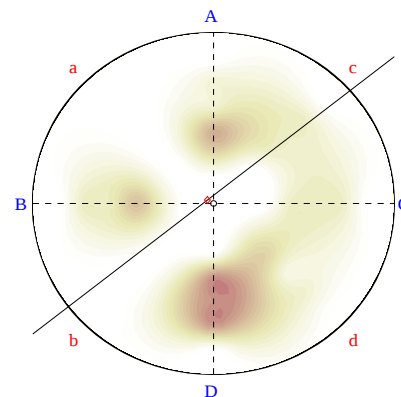
Figure 3: Decayed areas

Figure 3 shows decayed areas identified from ultrasonic tests. The percentage of decayed areas is 20 % of the section area, approximately.

The non-destructive evaluation shows that the tested section has some decayed areas. The wood pole has to be scheduled for rehabilitation.

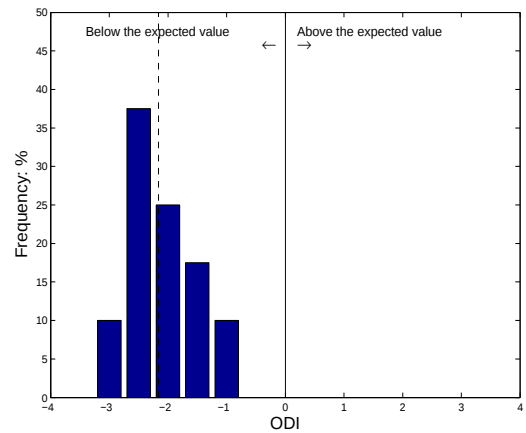
Figure 2: Overall dissimilarity index

Parameters of wave velocity, wave attenuation, and the modulus of elasticity are combined to compute an overall dissimilarity index (ODI) for each raypath. The ODI represents a number of standard deviations respect to the expected value for a new pole and, therefore, describes the overall condition assessment of a cross-section. An ODI in the range  $[-2, -3]$  means that a cross-section has 98% probability that is decayed. The mean value and standard deviation of the ODI computed from 20 raypaths are  $\mu = -2.2$  and  $\sigma = 0.7$ .

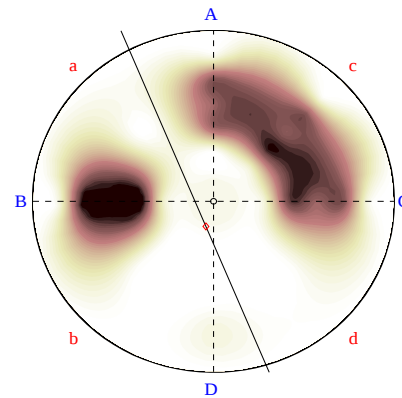
Figure 3: Decayed areas

Figure 3 shows decayed areas identified from ultrasonic tests. The percentage of decayed areas is 73 % of the section area, approximately.

The non-destructive evaluation shows that the wood pole RP-D12 has reached the End-of-life according to CSA C22.3 No. 1 (2006a).
