# Condition assessment of the wood pole RP-6-1

June 17, 2011

# Condition assessment of the wood pole RP-B-1-3

# Condition assessment of the wood pole RP-D12

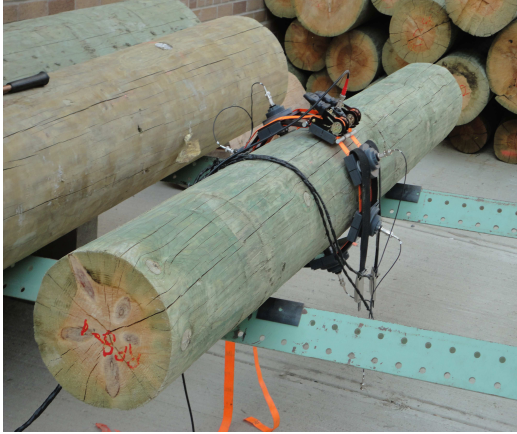
Figure 1: Ultrasonic pole testing (UPT)

The tested section of the wood pole RP-6-1 (Red pine) is 26.8 cm diameter. The wood pole is new and its condition assessment was evaluated using ultrasonic tests in the Testing-Lab, Department of Civil Engineering, University of Waterloo.

The condition rating index (CRI) is correlated to the expected remaining strength ratio. A  $CRI=1$  means that the expected strength of a tested section is similar to the expected value of a new pole. For the wood pole RP-6-1,  **$CRI = 1.05$** .

No decayed areas were detected in the tested cross-section.

The non-destructive evaluation shows that the tested section is sound.

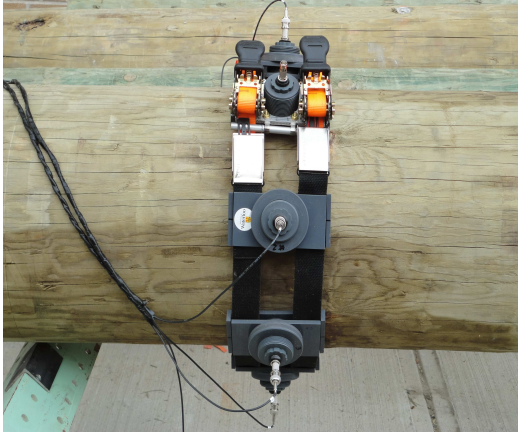
Figure 1: Ultrasonic pole testing (UPT)

The tested section of the wood pole RP-B-1-3 (Red pine) is 37.7 cm diameter. The wood pole is new and its condition assessment was evaluated using ultrasonic tests in the Testing-Lab, Department of Civil Engineering, University of Waterloo..

The condition rating index (CRI) is correlated to the expected remaining strength ratio. A CRI=1 means that the expected strength of a tested section is similar to the expected value of a new pole. For the wood pole RP-B-1-3 , **CRI = 0.77**.

Figure 3 shows decayed areas identified from ultrasonic tests. The percentage of decayed areas is 20 % of the section area, approximately.

The non-destructive evaluation shows that the tested section has some decayed areas. The wood pole has to be scheduled for rehabilitation.

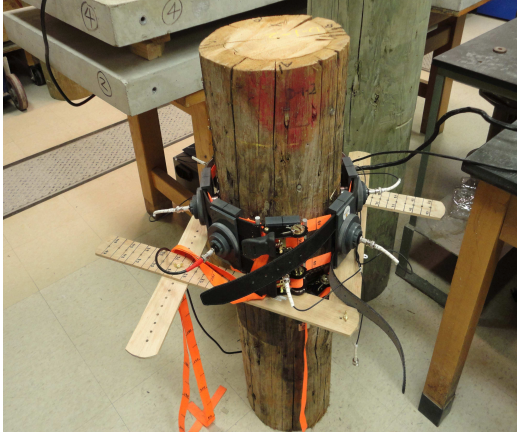
Figure 1: Ultrasonic pole testing (UPT)

The wood pole RP-D12 (Red pine) has been in-service for 32 years. The tested section is 26.7 cm diameter. The condition assessment of the wood pole was evaluated using ultrasonic tests in the NDT-Lab, Department of Civil Engineering, University of Waterloo.

The condition rating index (CRI) is correlated to the expected remaining strength ratio. A  $CRI=1$  means that the expected strength of a tested section is similar to the expected value of a new pole. For the wood pole RP-D12 ,  **$CRI = 0.43$** .

Figure 3 shows decayed areas identified from ultrasonic tests. The percentage of decayed areas is 73 % of the section area, approximately.
