# A new methodology for condition assessment of utility wood poles based on ultrasonic waves

Fernando J. Tallavo  
Giovanni Cascante  
Mahesh D. Pandey

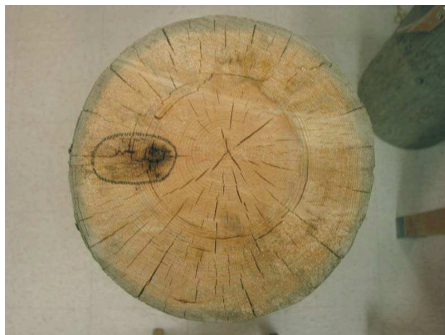
- Destructive evaluation
- ✓ New red pine pole
- ✓  $\phi_{pole} = 33$  cm
- ✓  $MOR = 35.02$  MPa
- ✓  $I_r = \frac{MOR}{45.5} = 0.77$

- Non-destructive evaluation
- ✓  $E[CR] = 0.92$
- ✓  $E[E_l] = 10.5$  GPa,  $COV = 0.12$

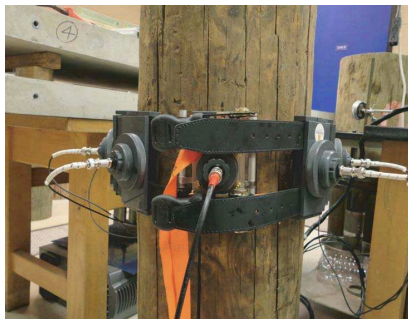
- ✓ 22 years in-service
- ✓  $\phi_{pole} = 30$  cm
- ✓ Internal decay level = 2
- ✓  $MOR = 30.10$  MPa
- ✓  $I_r = \frac{MOR}{45.5} = 0.66$

- ✓  $E[CR] = 0.72$
- ✓  $E[E_l] = 8.4$  GPa,  $COV = 0.14$
